STANDARD CONSTRUCTION DRAWINGS

TYPICAL TRENCH RESTORATION
NOT TO SCALE

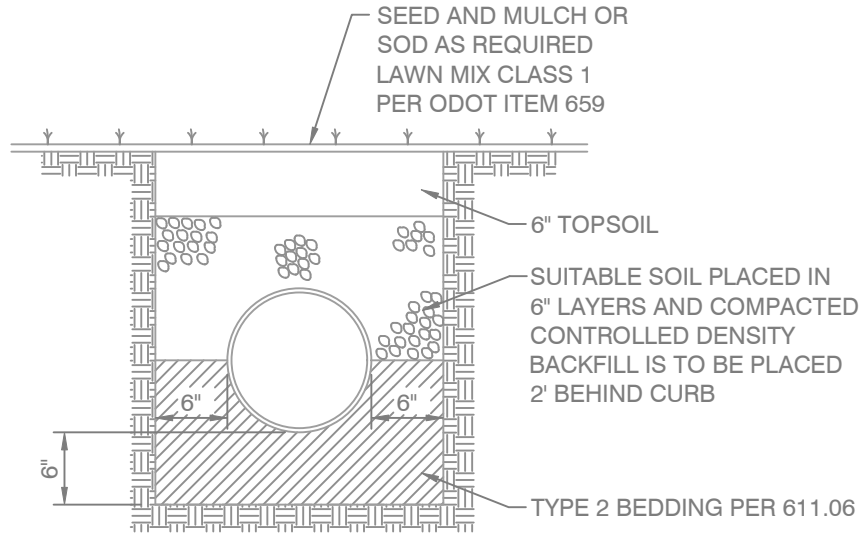
(IN GRASS AREAS)

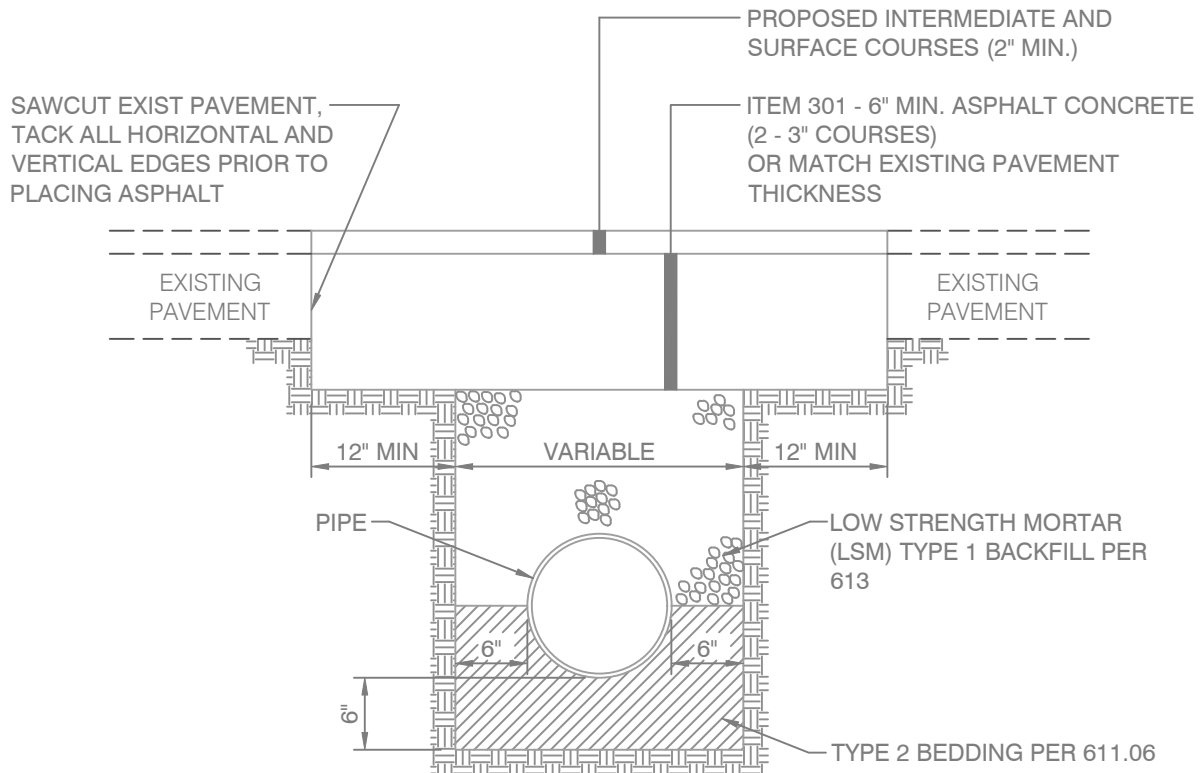
(IN PAVEMENT)
